PARK DRIVE & RAYE ROAD DRAINAGE PROJECT

CALN TOWNSHIP, CHESTER COUNTY, PA

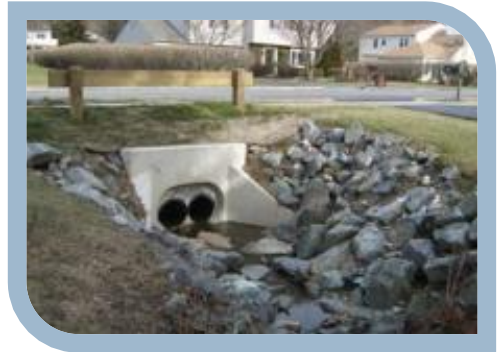
PARK DRIVE

Two (2) existing parallel CMP pipes crossing beneath Park Drive, which discharge into an adjacent creek, had been showing significant signs of corrosion. The deteriorating culvert was collapsing as evidenced by areas of depressed pavement in the roadway and cracked concrete along the curb line.

April Barkasi, President of CEDARVILLE Engineering Group, LLC., was the Project Manager responsible for the design and for the installation of 120 lf of new storm pipe, as well as two new inlets and a new endwall. All existing site and flow conditions were considered and evaluated in the design.

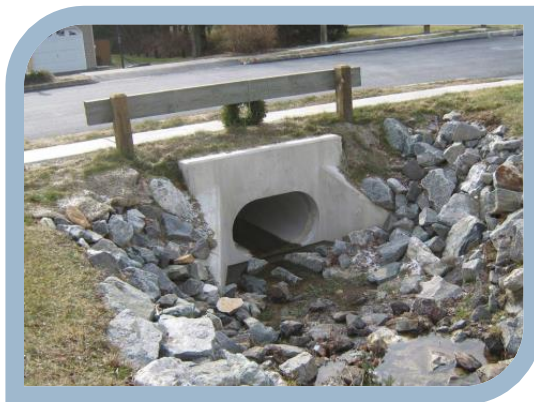
RAYE ROAD

Due to the deteriorating condition of the existing CMP culvert crossing beneath Raye Road, this culvert did not function properly during major storm events. The corroded culvert was also beginning to collapse, as evidenced by areas of depressed pavement in the roadway.

Ms. Barkasi researched existing flow conditions and designed the new system to replace 70 lf of CMP culvert as well as three damaged inlets with a new RCP culvert and three new stormwater inlets to fit the tight conditions around other existing utilities, as well

as re-contouring the roadway to create appropriate low points in the area of the two new inlets and thus alleviate ponding in the roadway.
